Manhole Inspection Summary

Manhole # S15I__012MH

Inspection ☐ Is Incomplete Rating: **4) Poor**

Location Address: **2578 alley-hollins-baltimore** Cross Street: **franklintown rd**

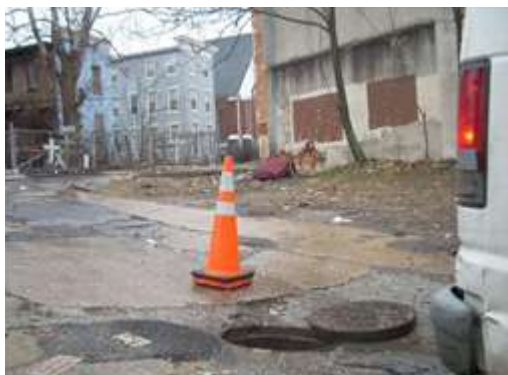
Location View

Manhole Type: **Terminal** Location: **Alley** Ground Conditions: **Wet**
☐ Prev. Rehab Weather: **Light Rain** Subject To Ponding: **Sheeting**

ground around manhole is in poor shape

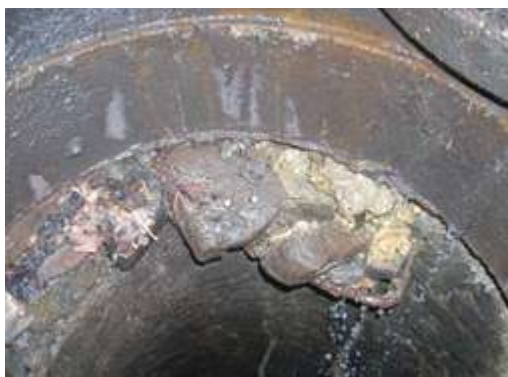
Defect 4

Chimney / Frame Adjustment ☒ Exists Material: **Brick and Stone** ☐ Parged Height: **4** (in.)

Condition: ☐ Sound ☐ Cracked ☐ Root Intrusion ☐ Loose Brick ☒ **Deteriorated**

deteriorating chimney

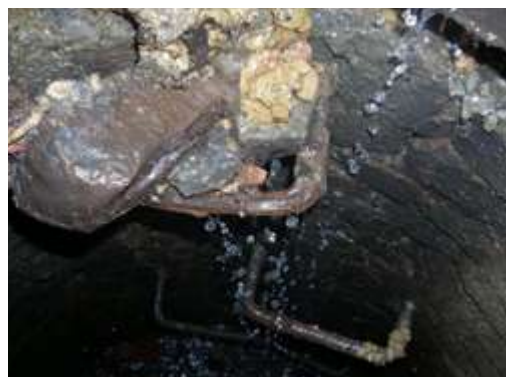
Defect 5

Steps Count: **4** Missing: **0** ☒ **Corroded**

step is corroded

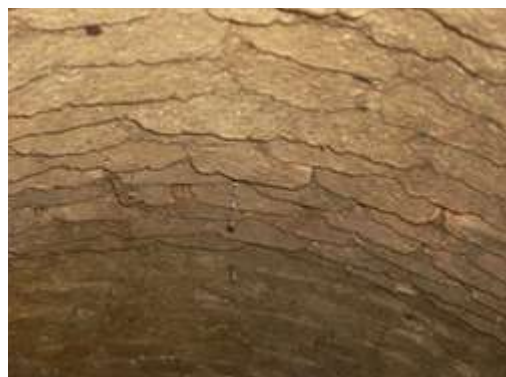
Defect 3

Infiltration: ☐ None ☐ Joint ☐ Cracks ☐ Mortar ☐ Roots ☒ **Wall**

infiltration drips from corbel wall

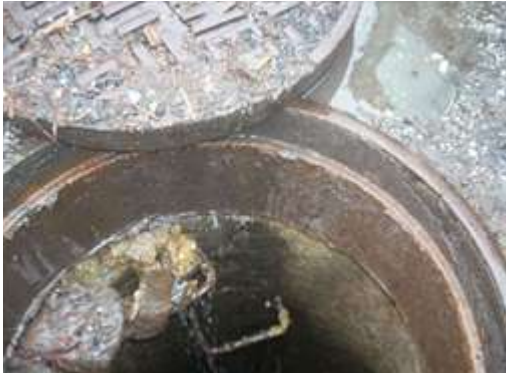
Defect 2

subject to sheeting, a lot of water flowing into manhole, Inflow and Infiltration

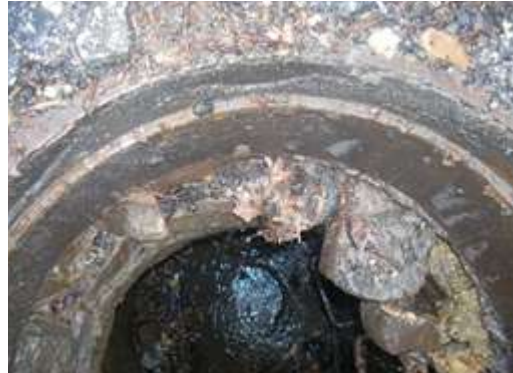
Defect 1

Frame Offset: **3** (in.) Condition: ☒ Sound ☐ Cracked ☐ Leaks

frame offset

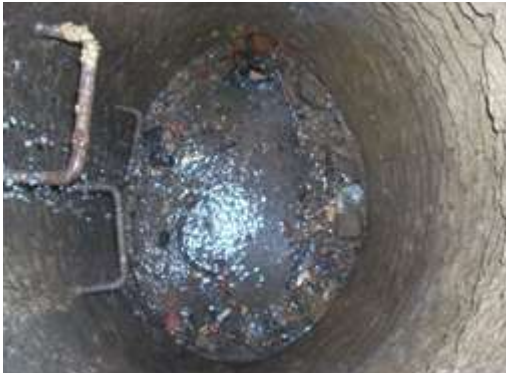
Defect

Condition: ☐ Sound ☐ Cracked ☐ Root Intrusion ☐ Deteriorated ☐ Leaks ☒ **Debris**

channel debris

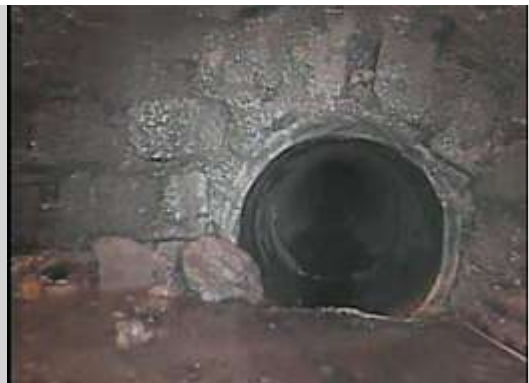
12 O'Clock Outflow

8 in. Circular Gravity Sewer
Pipe Out @ 12 O'Clock

Infiltration: **None** Pipe Seal Cond: **Broken**
